Manhole Inspection Summary

Manhole # S31AA2005MH

Insp Date: **4/16/07 10:02 AM**

Location Address: **5406 SAINT ALBANS WAY**

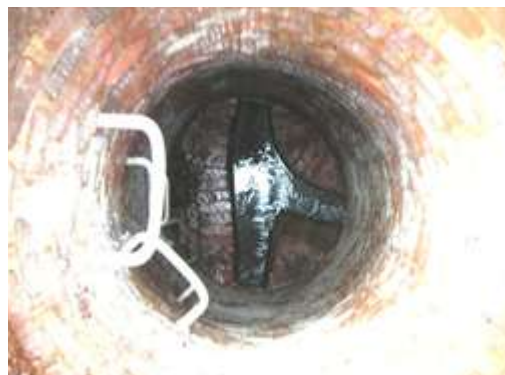
Top View

Corroded steps. Evidence of surcharge - Bench debris.

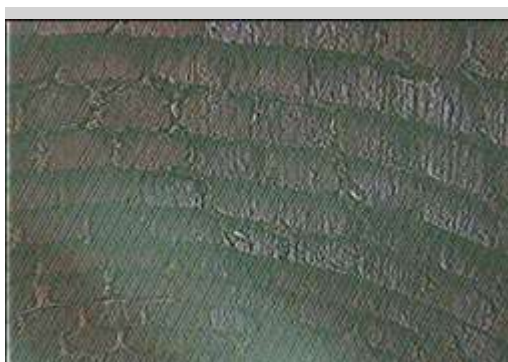
Defect

Corbel and Barrel deterioration and infiltration.

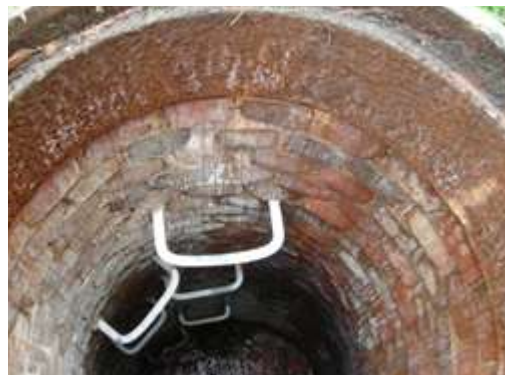
Defect

Adjustment deterioration and infiltration. Corbel and Barrel infiltration.

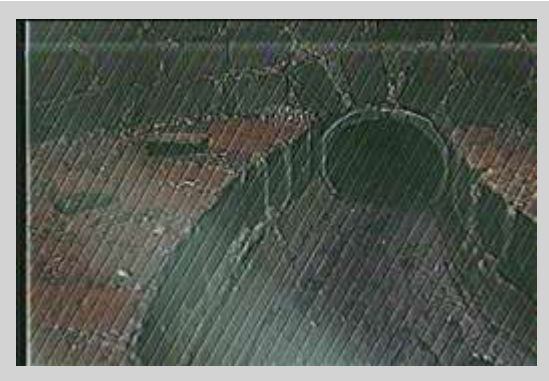
8 in. Circular Gravity Sewer Pipe Out @ 12 O'Clock

Deposits: ☐ None ☒ **Mud** ☐ Sludge ☐ Debris ☒ **Grease**

Silt Depth: **0.5** (in.) Deposits Extent: **Light**

Infiltration: **Evidence** Pipe Seal Cond: **Cracked**

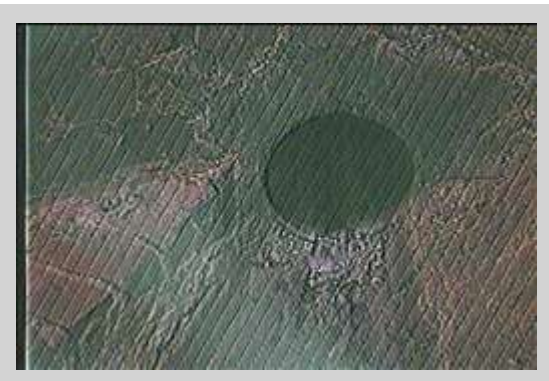
8 in. Circular Gravity Sewer Pipe In @ 3 O'Clock

Channel deterioration.

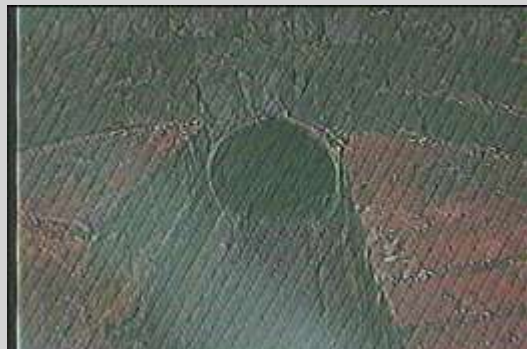
Pipe In @ 5 O'Clock

Barrel deterioration and infiltration. Channel deterioration.

Pipe Seal Cond: **Cracked**
